Automotive Seal Manufacturer Improves Quality with Pyropel®

Rubber Molder - Indiana, USA

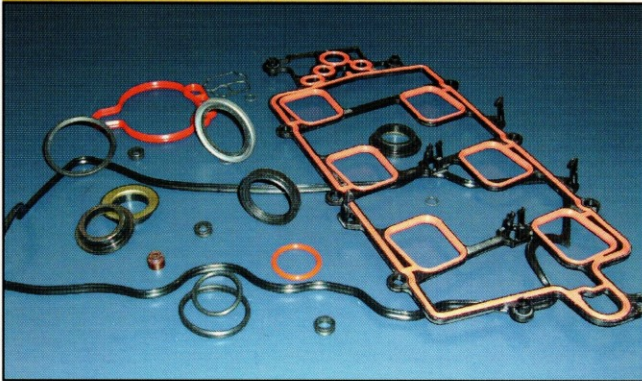
Elastomeric Seals

Precision seals and gaskets used in automotive applications

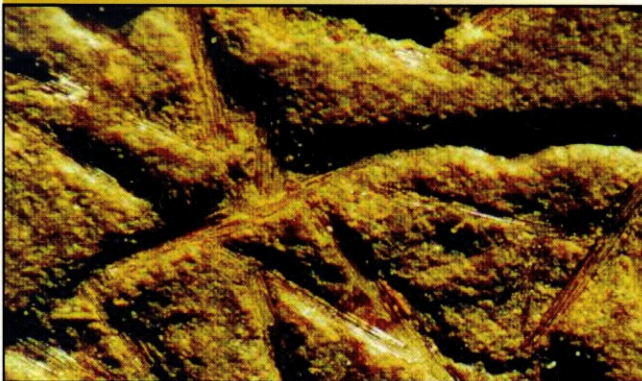
Thermally Degraded Insulation

Thermally degraded glass reinforced polyester platen insulation can cause major quality issues if not properly addressed. The above microscopic photograph shows how the polyester binder has been destroyed and only a skeleton remains.

Customer Challenge: The brake seal molding facility was having difficulty maintaining tight product tolerances because of the failing glass reinforced polyester platen insulation. The boards were degrading and losing parallelism, and the molds were not closing properly. The problem was so significant it required the insulation boards to be replaced every six to eight weeks.
